# CNSL

## READINESS STANDARDS GUIDE

### AVIATION

#### **HORIZON REFERENCE SET (HRS)**

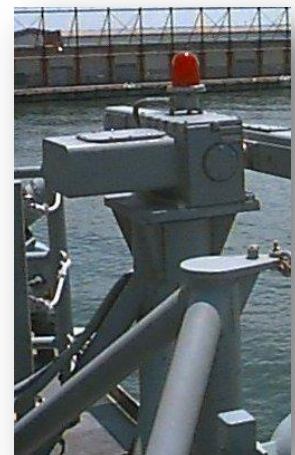
- Issue: Corrosion, chipping and flaking paint, worn weatherproofing on cables
  - Perform 4926/RHR-50 S-1 (Clean and Inspect HRS Sub-Assemblies) to identify material discrepancies
- Issue: Missing securing hardware causing water intrusion
  - Perform 4926/RHR-50 S-1 (Clean and Inspect HRS Sub-Assemblies) to identify material discrepancies
  - Perform 4926/RHR-50 R-1 (Perform Pre-Recovery Test) after repairs
- Issue: Worn or dried out gaskets or o-rings
  - Perform 4926/RHR-50 S-1 (Clean and Inspect HRS Sub-Assemblies) to identify material discrepancies
  - Perform 4926/RHR-50 R-1 (Perform Pre-Recovery Test) after repairs
