28 Feb 14

Subj: COMMAND INVESTIGATION INTO THE FACTS AND CIRCUMSTANCES  
SURROUNDING THE USS TAYLOR'S (FFG 50) POSSIBLE GROUNDING  
IN VICINITY OF (IVO) SAMSUN, TURKEY

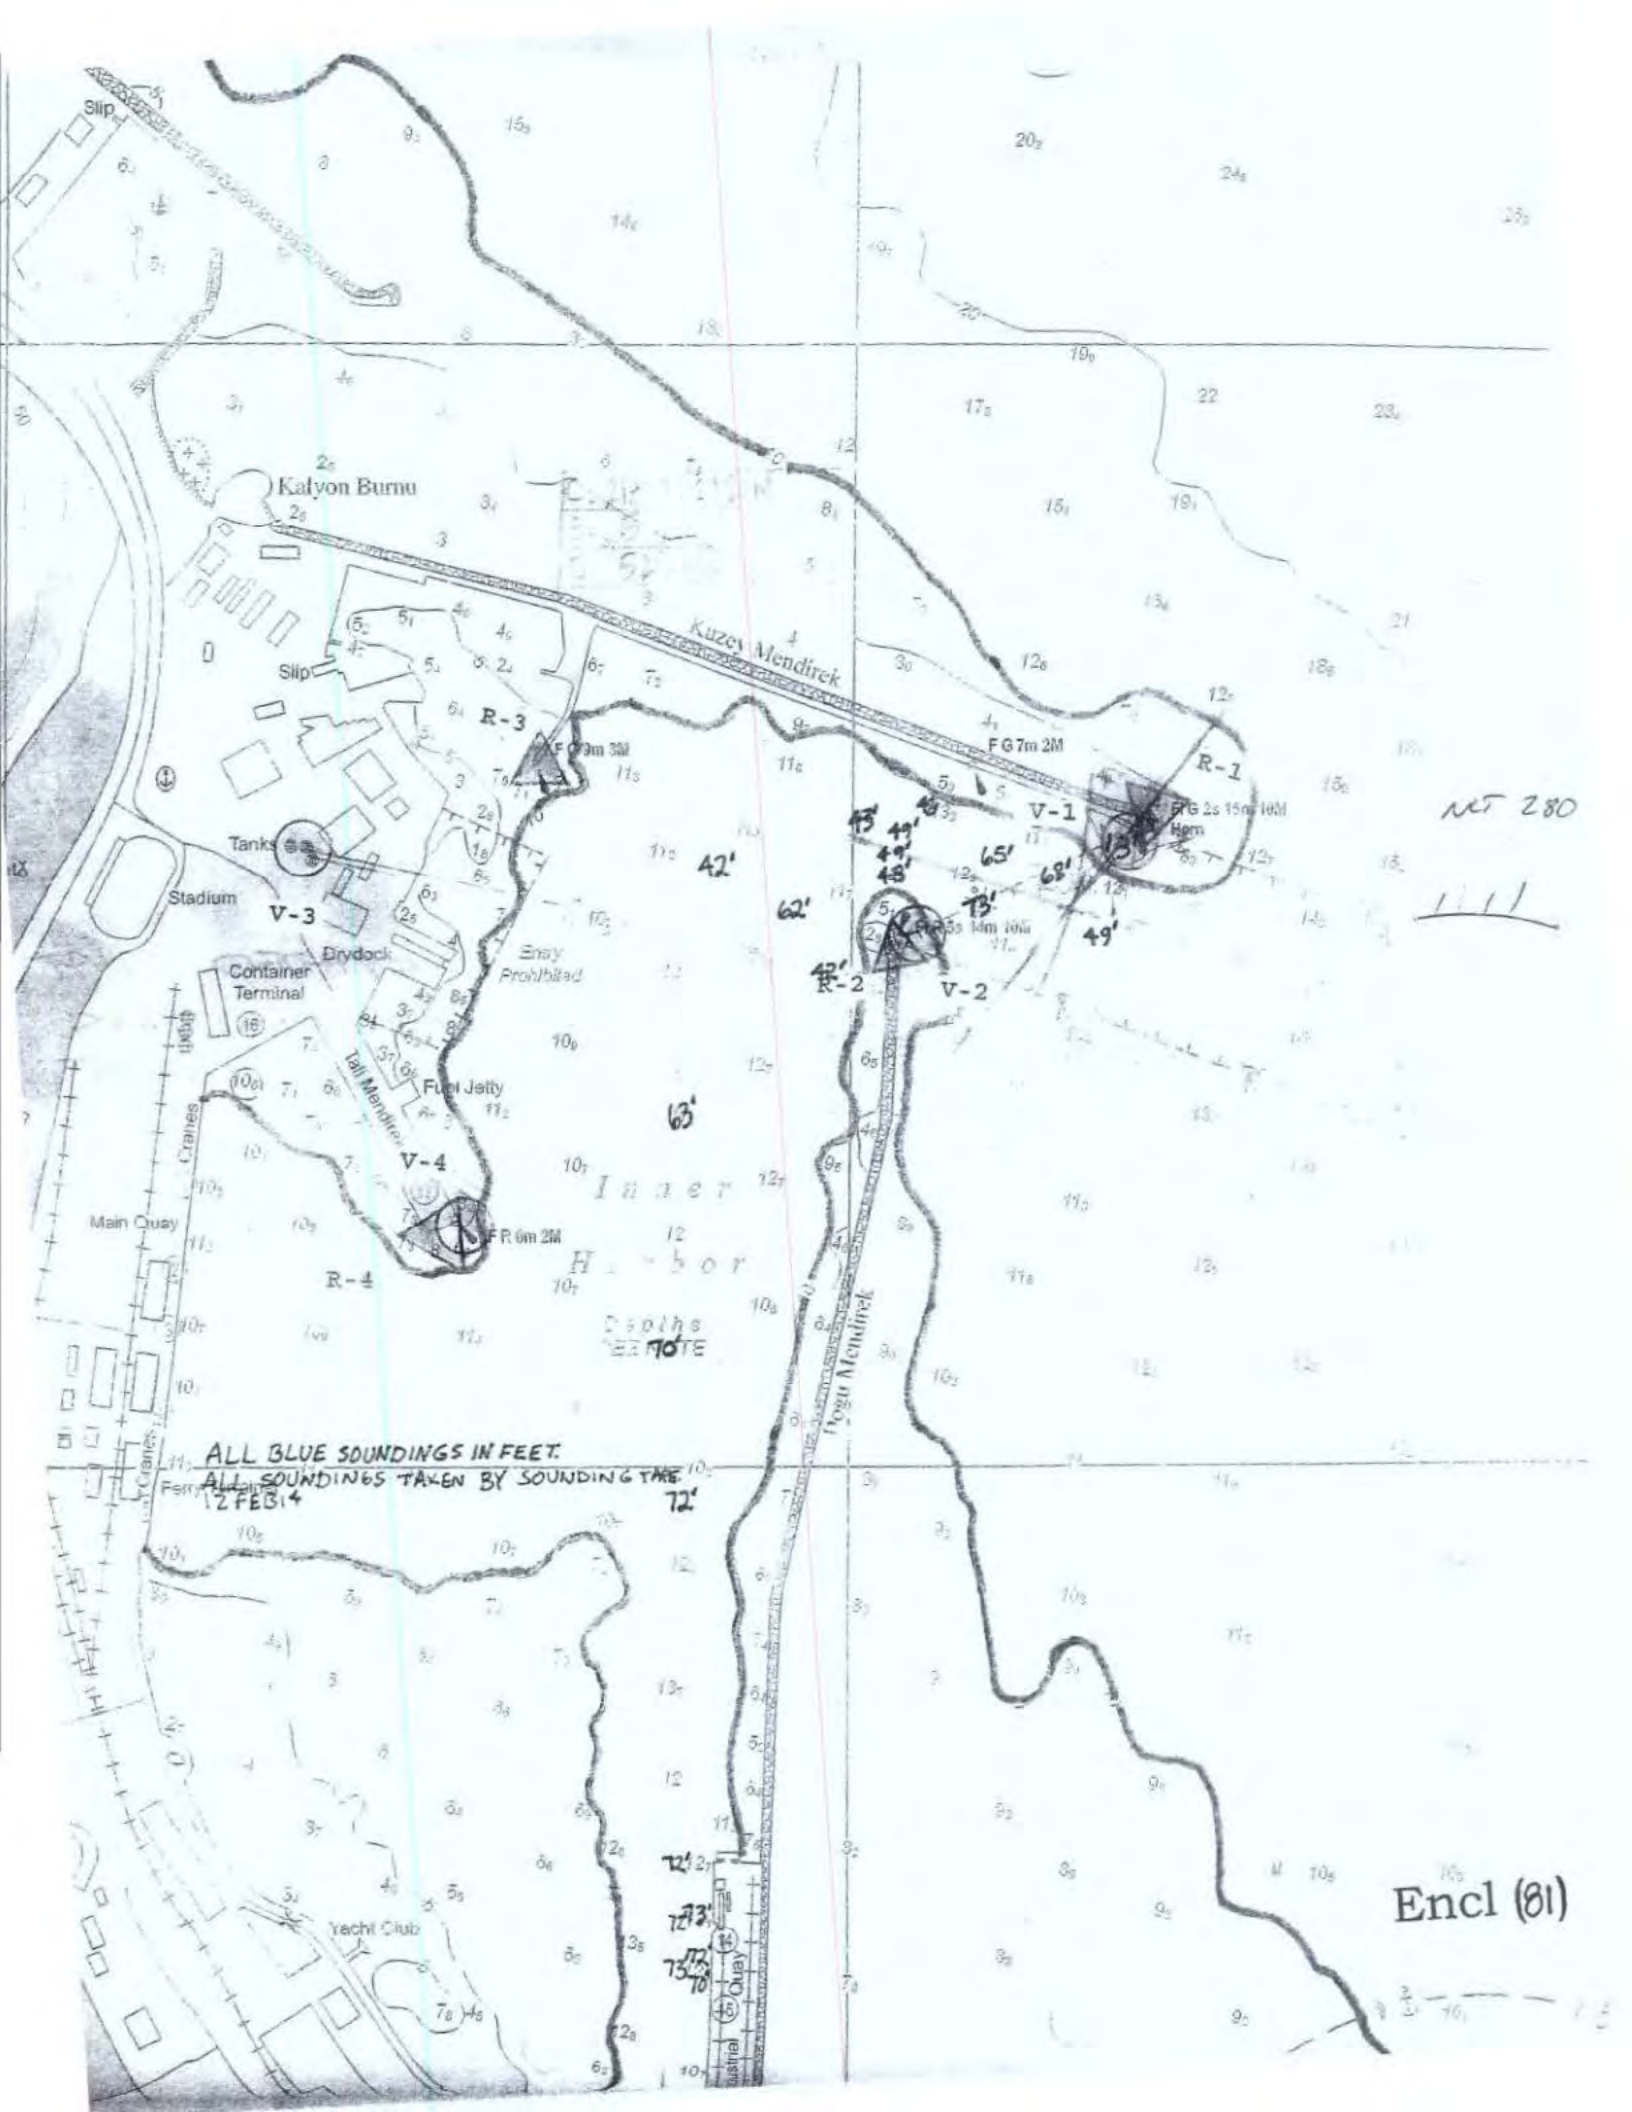
ALL BLUE SOUNDINGS IN FEET.  
 ALL SOUNDINGS TAKEN BY SOUNDING TANK  
 12 FEB 14

14. Commander, SIXTH Fleet should review periodicity of harbor surveys in conjunction with fleet port scheduling. The EOD MU8 survey data showing 25 foot soundings indicate that the survey periodicity on this port was insufficient to prevent undetected shoaling. This does not mitigate the responsibility of the ship to remain clear of the hazard if able, and there was ample opportunity, information, and ability for USS TAYLOR (FFG 50) to do so.

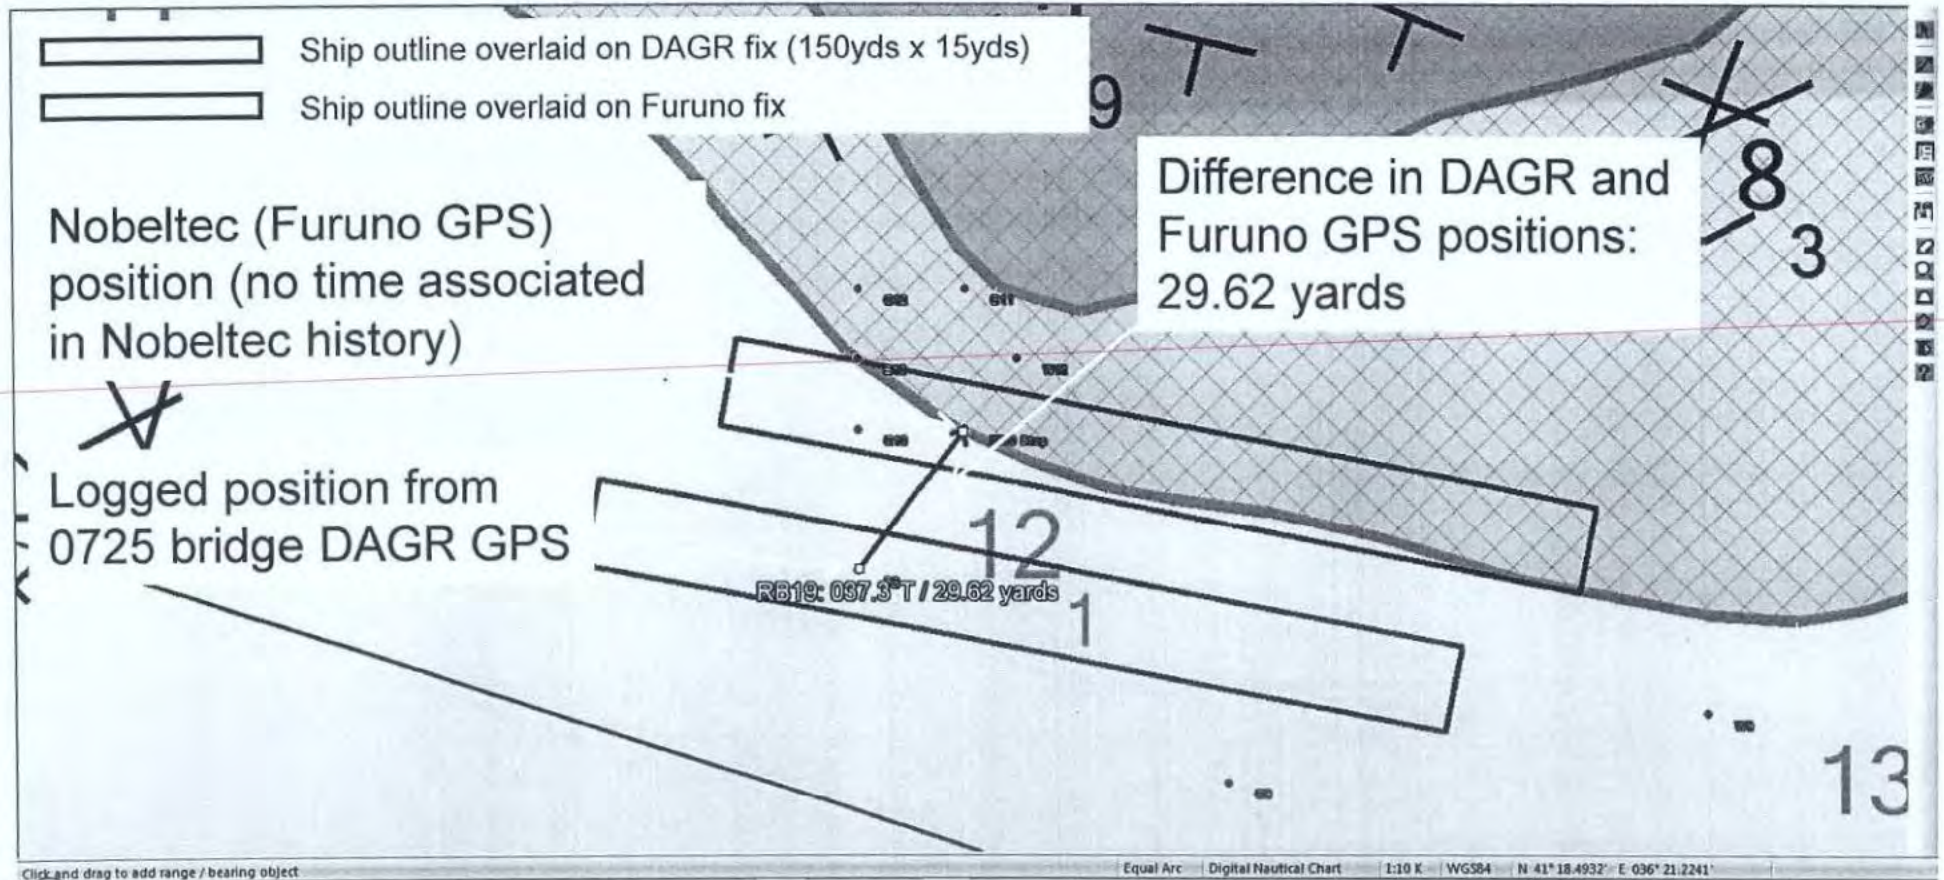
# Offset distance – Furuno & DAGR

- b. Failure to recognize that the manner in which they chose to plot GPS fixes impacted the margins they had in a narrow channel. Bridge DAGR GPS was recorded to the nearest second of arc which equals 33 yards. CIC DAGR was recorded to the nearest .01 minutes of arc which equals 20 yards. This method is not inappropriate; however, the ship did not account for this by applying an offset to the hazard. [FF (19), (20), (51)]

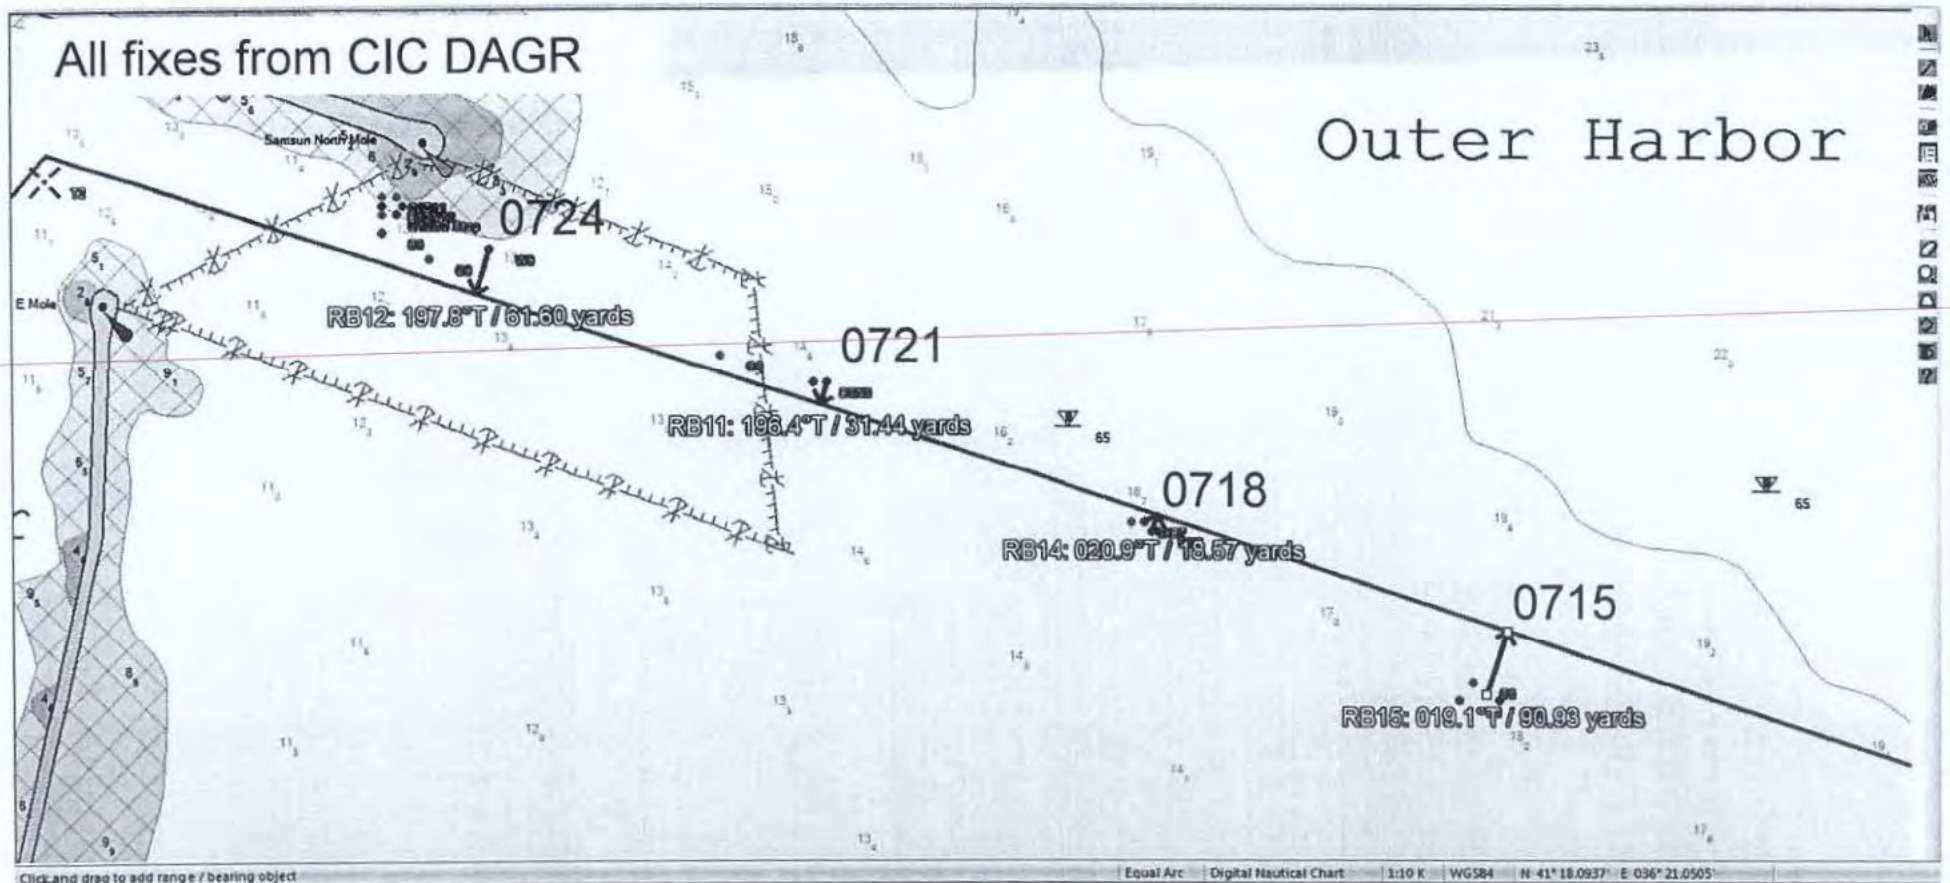
# Positions in Relation to Track

9. While almost all members of the navigation team knew they were right of track, no one recommended or took aggressive action to correct the situation. [FF (75), (76), (98), (99)]

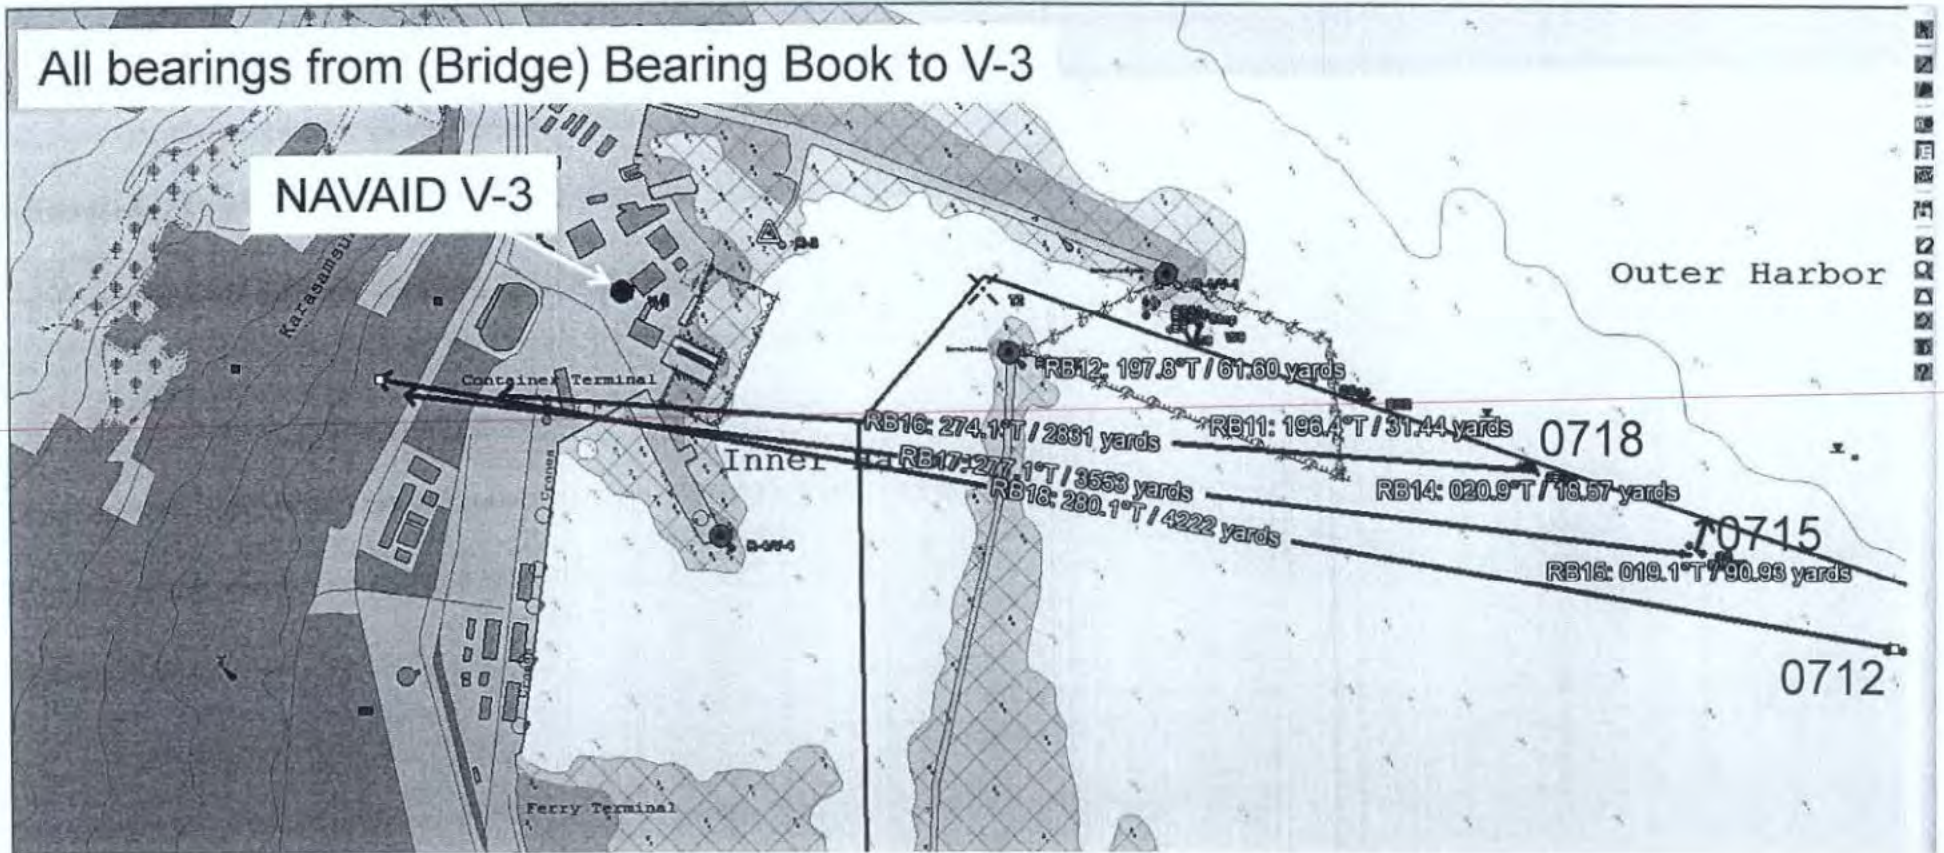
# Logged Bearings to V-3

- a. The turn bearing to V-3 was logged as 116R. The correct turn bearing should have been 063R.
- b. The turn range to R-4 was improperly labelled as 925 yards. The correct range was 750 yards.
